# Elevating and Amusement Devices Safety Program

Ref. No.: 278-19

## **ADVISORY**

Otis Brake Lever for 130, 131, 139 and 156 series Gearless Machines

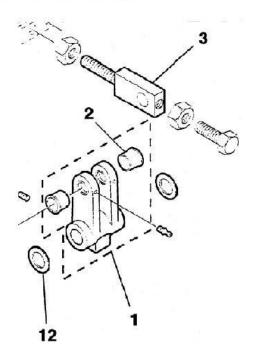
Figure 3: Brake Lift Geometry Bushed Lift Pin

Due to the additional height of the hardened bearing button, the brake lift will need to be re-adjusted at bolt "3" in the image below
