<b>Elevating and Amusement Devices Safety Program</b>	Ref. No.: 281 / 19
<b>ADVISORY</b>	Date: September 5, 2019

**Subject:** Turnbull Spring Hitch  
**Distribution:** TSSA website

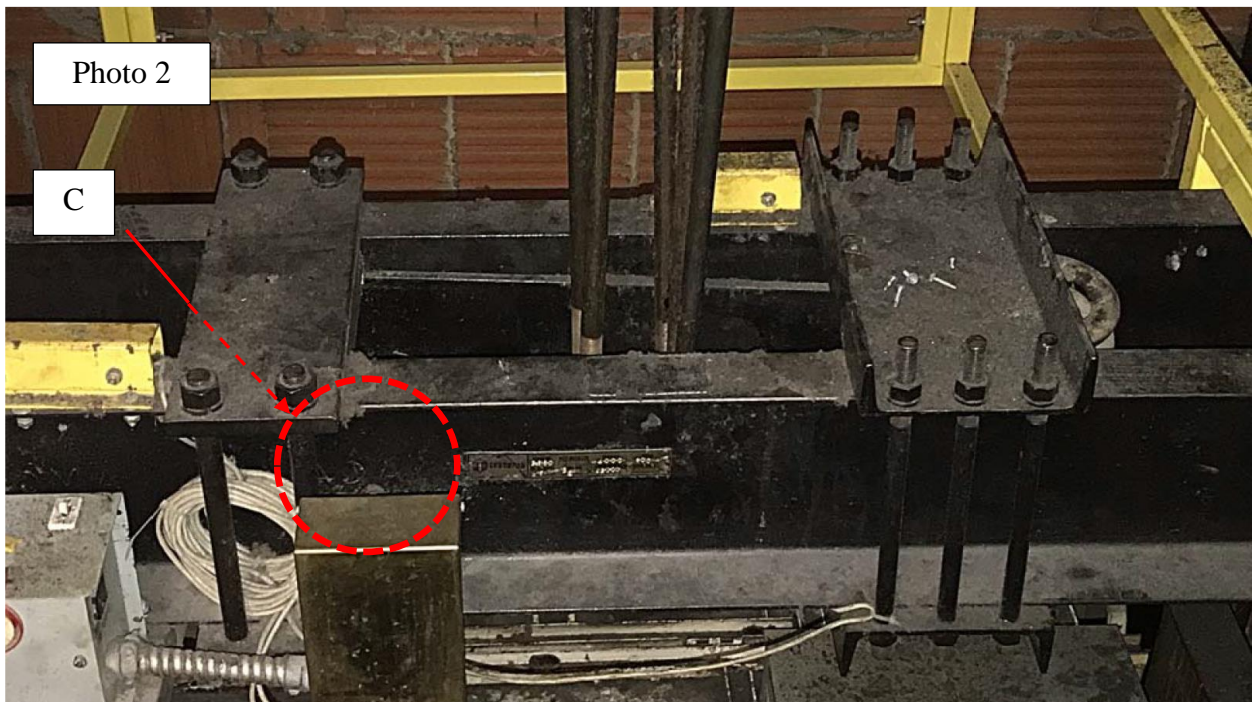
Photo 2  
Overview of spring hitch arrangement

[C] Area where spring hitch is located - between crosshead members (not visible in photo)

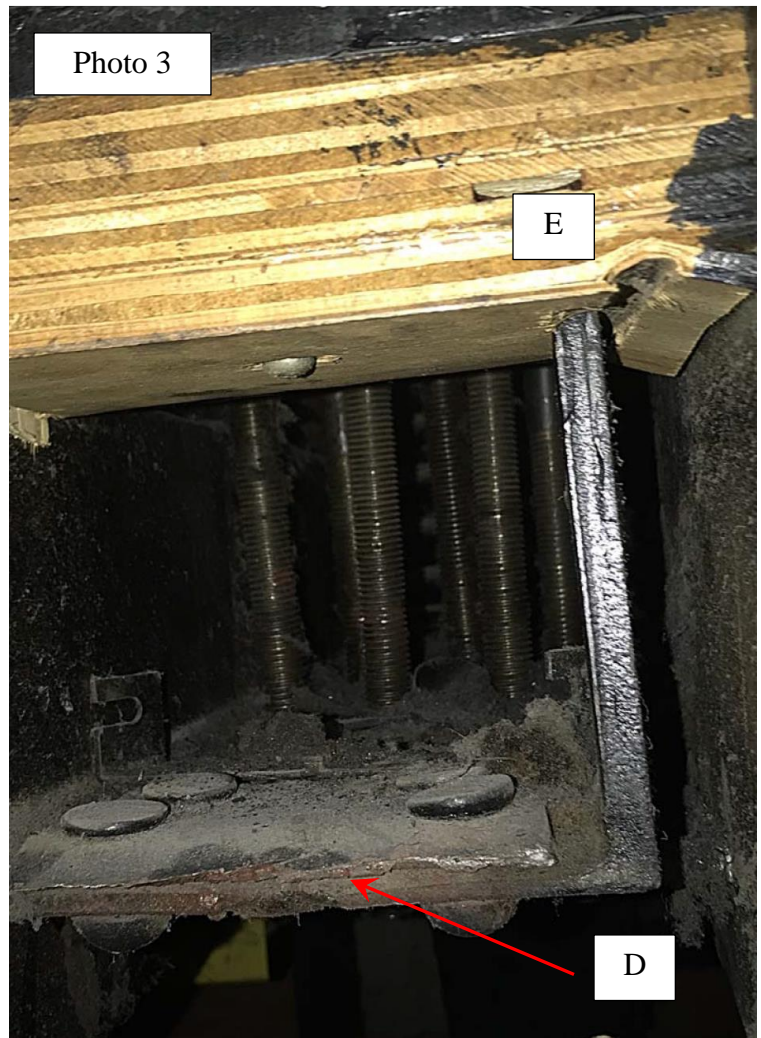
Photo 3

This failure was recently observed during a period inspection, and contractors and mechanics should be aware of this issue.

[D] Showing failed spring hitch

[E] Inverted 'C' Channel has embedded itself in the wood blocking (added per Turnbull drawing 3B00247)

An area of fatigue is identified in the drawing below, and its integrity should be routinely assessed.
